Structural Performance and Seismic Vulnerability of Adobe Historical Constructions. The Kuño Tambo Case Study.

Georgios KARANIKOLOUDIS, Paulo B. LOURENÇO

Article disponible dans les actes du colloque Terra 2016:

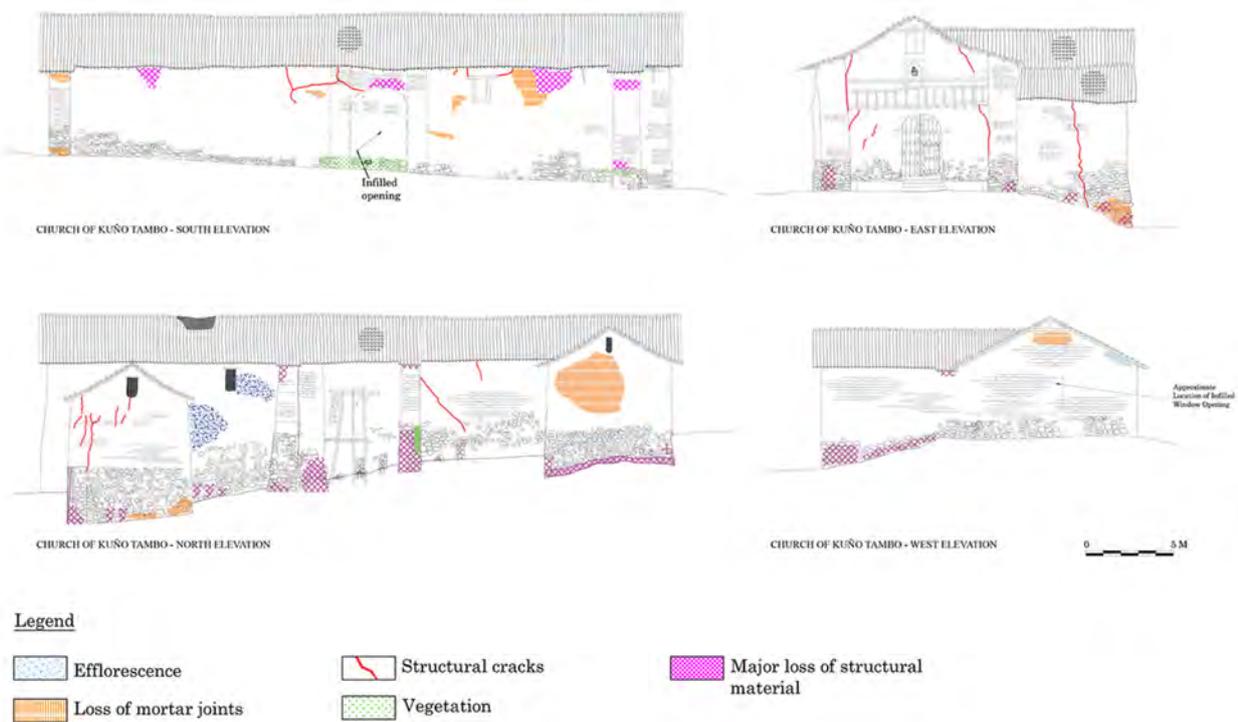
Fig. 3 Damage maps in each facade [5].

The damage configuration, is highly influenced by the low mechanical properties of adobe masonry, the poor level of confinement of structural parts, and the high level of exposure of exterior surfaces to erosion, from improper drainage and maintenance. The east façade shows signs of discontinuity with the lateral walls, with evident vertical cracks at both ends. The south lateral wall exhibits outward displacements, loss of mortar and units, while the base course has evident signs of erosion and deterioration in many exterior parts, with loose stones and missing mortar from joints.

The baptistery exhibits several vertical cracks, located in the middle span of the sidewalls and at the east corner of the gable wall, which appear to be related to seismic action or settlements, triggered by the difference in the thickness. The crack at the corner is characteristic of a separation mechanism of orthogonal walls, from pounding during earthquake events or soil settlements [2]. The presence of damage in all the facades is presented in Fig. 3 [5].

Lastly, several areas of the building are in need of stabilization actions, due to mortar joint loss and loss of adobe and stone units. Immediate action is recommended to prevent damage increase and reduce the risk of fabric loss.

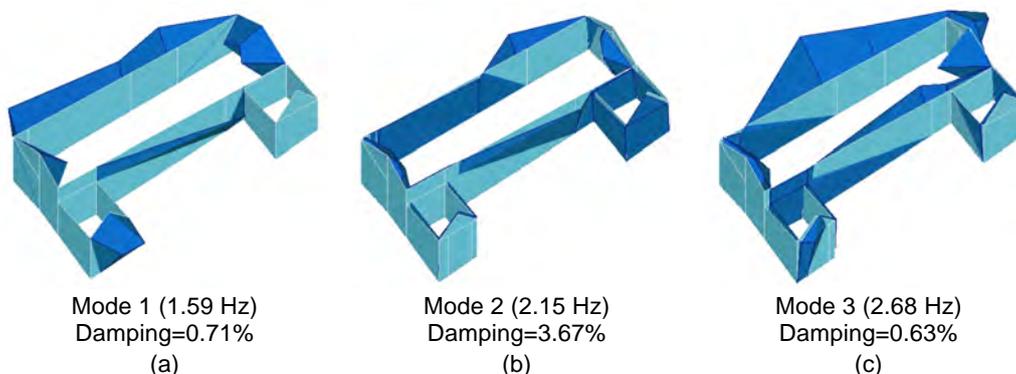
Fig. 5 Mode shapes from dynamic tests, of the first three modes, with interpolation [10].

The dynamic behavior of the church of Kuño Tambo, as identified from ambient tests conducted in May 2015 [10], is characterized by out-of-plane bending modes, in single and second order curvatures, for the lateral and gable walls of the nave. These configurations provide feedback on the low level of connectivity at the corners, approximating true cracks.

Experimental mode 1 (1.59 Hz) consists of independent orthogonal bending modes, of single curvature, for the nave walls, configured in an out-of-phase symmetry in both axes, with high peaks and similar amplitudes, clearly due to similar stiffness, mass and damping properties (Fig. 5a). Due to the presence of damage, an evident decrease of the natural frequencies and an alteration of the mode shape vectors are found, in comparison to the results of modal analyses, with total continuity in the wall connections, and no ties present.

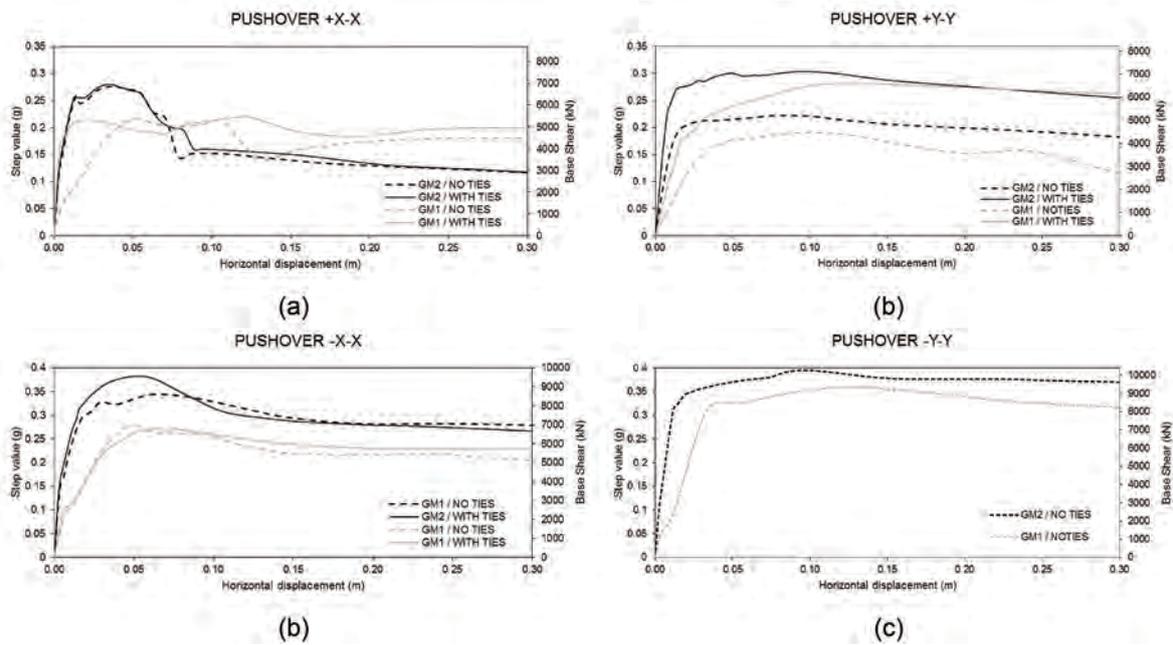
Fig. 6. Response of structure in all directions and axes, for Models GM1 and GM2.

Regarding the pushover analysis in the positive x-x direction, the minimum lateral load applied is 0.22g for Model GM1_{no ties} (Fig. 6a). The failure mechanism consists of vertical separation cracks, along the corners, in the west part of the church, with horizontal hinge lines at the bottom of the base course foundation. Model GM2 is stiffer and the lateral capacity is around 30% higher than Model GM1, with the ties not offering any strengthening in the longitudinal direction.

The structure experiences the lower lateral capacity in the positive y-y direction, equal to 0.19g (GM1_{no ties}) (Fig. 6b). With the presence of ties, the obtained capacity values are 47% and 37% higher than the ones without ties, for models GM1 and GM2 respectively. Regarding the ties, are all under tension and their ultimate capacity is specified from the pull-out failure of their anchored connection. From tests on timber ties and wood key anchors, on adobe specimens of various thicknesses, conducted at PUCP [9], and given the thickness of the lateral walls, the maximum pull-out force is 96 kN, but partial safety factors should be considered. For ties close to the corners, the ultimate axial force is reached at the early stages of post-peak behavior. Due to transversal restraint, interfaces between the east lateral wall, the baptistery, the buttresses and the sacristy suffer extensive tensile damage and are almost separated.

In the negative x-x direction, the failure mode consists mainly of the out-of-plane overturning of the east façade, together with adjacent fragmented parts of the lateral walls, as shown in Fig. 6c and Fig. 7. The minimum obtained lateral capacity is 0.28g in the less stiff model (GM1_{no ties}). With effective ties, the structure presents higher capacity and the ties appear to provide some restraint to the lateral walls and limit flexural out-of-plane deflections. Nevertheless, this is considered a local effect.

Lastly, from the results of the pushover analysis in the negative direction of the y-y axis, the structure presents the highest lateral capacity, in this case 0.36g and 0.39g (Fig. 6d), for Models GM1 and GM2 respectively, with the abutments on the north part contributing much more to the overall stiffness. The tensile damage is mostly concentrated in the sacristy, which fails early at 0.16g and 0.25g for models GM1 and GM2 respectively. Yet, no such damage exists on current state. Regarding the behavior of the tie beams, their axial force is gradually reversing from tension to compression, due to the difference of

According to the pushover analyses, strengthening is needed in multiple directions, since the overall capacity does not reach the peak ground acceleration for the Cusco region (0.25g) [20], as depicted in Table 2. One of the structural deficiencies of the church is the large asymmetric distribution of stiffness in the transverse direction of the nave. The failure mode with the lowest capacity, the out-of-plane overturning of the south lateral wall, controls the response, and the obtained minimum value is 0.19g, for the less stiff model. The possible reintroduction of the buttresses in the east part will increase the stiffness and global capacity.

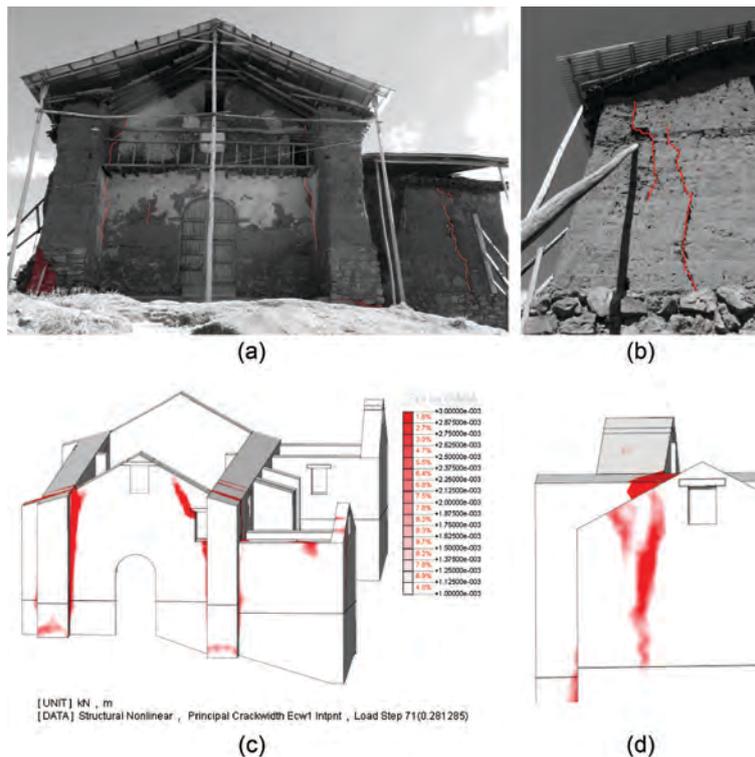
Fig. 7. Crack pattern correlation: (a) east façade; (b) gable wall of baptistery; (c), (d) distribution of principal crack width at load step near collapse (Model GM2_{no ties}).

The ties have a significant effect to the lateral capacity in the positive y-y direction. Yet, the capacity of the connections is considered low and given the dynamic character of the seismic forces, their performance is questionable. In order for the ties to work both in tension and in compression, anchor keys at both sides of the walls are needed or an internal timber truss is required. This would be a required practice in the definition of strengthening measures. New ties should also be added to reduce the large spacing between existing ones, as well as in the top of the baptistery and sacristy sidewalls, in order to limit out-of-plane collapse modes. The connectivity in the intersections between

walls can also be enhanced with the use of corner keys, placed in intersections between orthogonal walls.
